## Mechanical destruction due to thermal expansion

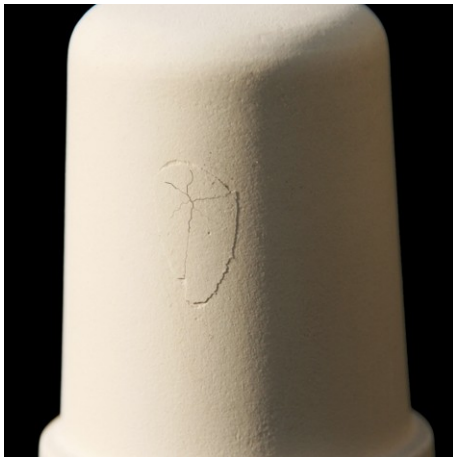
picture 1

Metal cubes, sprue cones or casting arms become wedged with the crucible wall (picture 3). During the melting process, the metal expands more than the ceramic and shatters the crucible. The appearance is characteristic. Starting from a central point, fine cracks diverge in the shape of spider webs (pictures 1 and 2). Often a whole shard is pressed out. The resulting hole becomes larger starting from the inner wall (picture 4).

Under all circumstances, wedging of the metal in the crucible must be prevented. The metal must lie loosely in the crucible. The metal needs enough space to expand during heating.
